Inspection Report

Logic Inspection Inc.

Inspector: Sasoon Yarijanian +1(818)858-5950 AHIT CA Certificate no. 781CA101

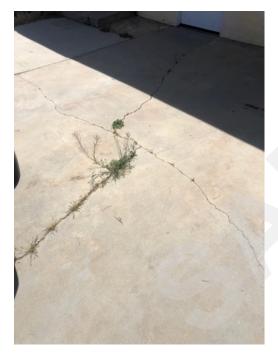
1.2) Driveway Conditions

Common cracks were observed in the driveway.

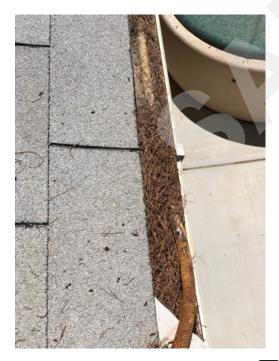
3.3) Gutter & Downspout Conditions

The gutter drains were blocked at the time of the inspection. Recommend clearing. This condition can cause water penetration in areas not readily visible or accessible.

missing downspout by entrance,

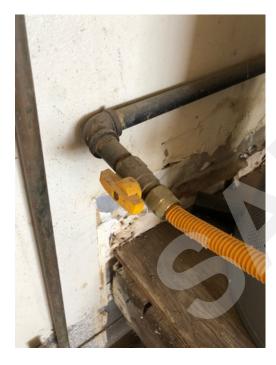
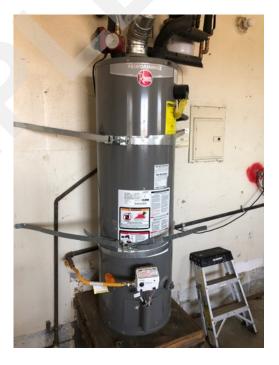
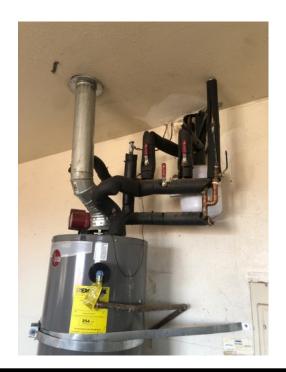
6.4) Water Heater Conditions

Improper / missing sediment trap installation observed. Sediment traps help to prevent debris from entering the pilot/burner portions of the system. Recommend further evaluation and repair by a licensed plumber.

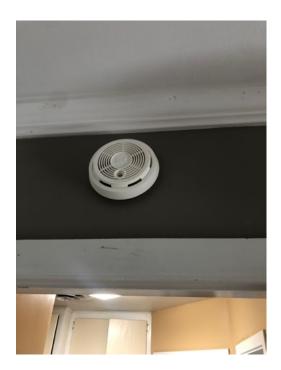
7.10) Smoke Detector Conditions

The smoke detector at master bedroom did not respond to the test button. Recommend repair or replacement prior to close. Carbon Monoxide detectors have a useful lifespan of about 5-6 years, it is recommended to replace all units after this time period.

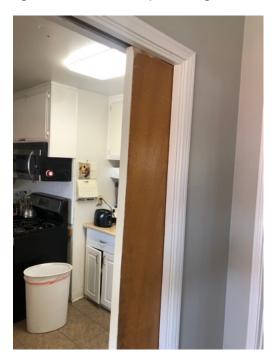
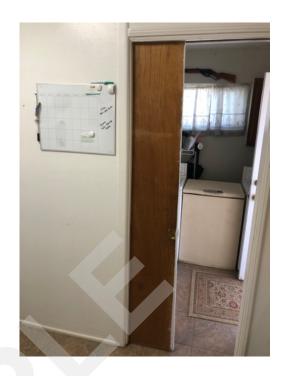
8.6) Kitchen Door Conditions

Sliding door is hard to operate, gets stuck on floor

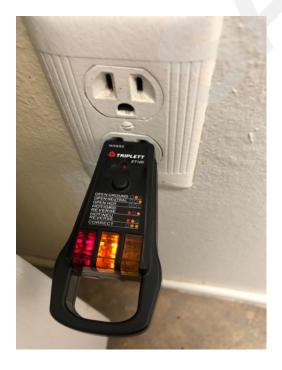
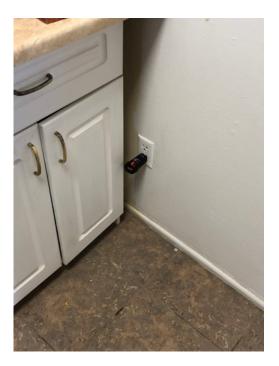
8.7) Electrical Conditions

Reverse polarity was noted at outlet(s) located at the kitchen by sliding door Reverse polarity, (hot and ground / neutral reversed) are usually corrected by minor wiring adjustments at the specified item. However, when a number of these conditions are observed, client should consult a licensed electrician.

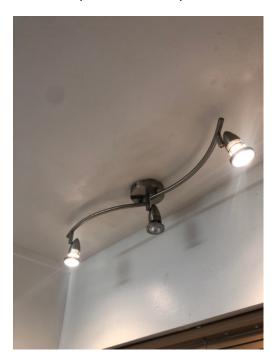
8.8) Lighting Conditions

Light(s) were out or inoperative by sink. Dismantling and testing of all light fixtures is not performed as part of this inspection. Recommend all lights be operable prior to close.

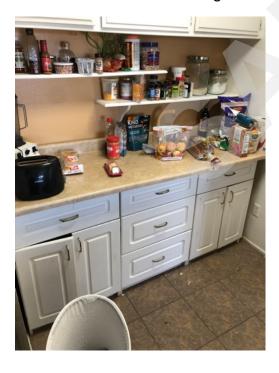
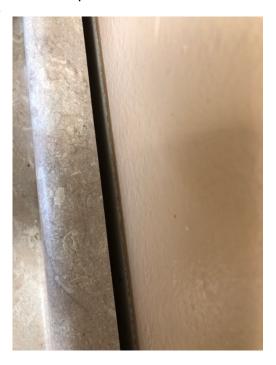
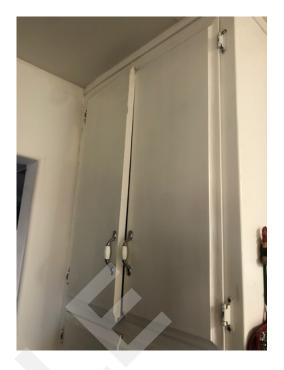
8.10) Cabinet Conditions

The cabinets were loose, and not fixed to the wall and not sealed, Recommend securing or repair as needed for increased safety.

The kitchen cabinets were damaged. Recommend repair and / or replacement.

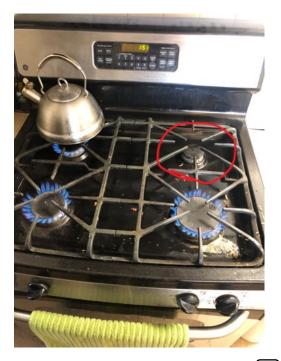
8.13) Stove - Range Condition

The burner on the cook top did not operate. Repair is needed.

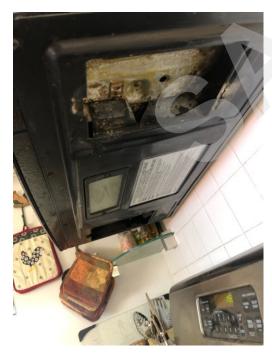
8.14) Hood Fan Conditions

The fan / hood filter was missing,

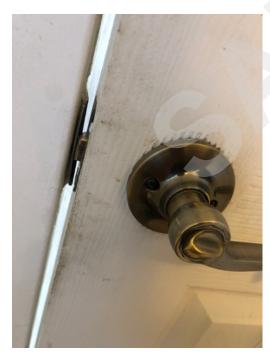
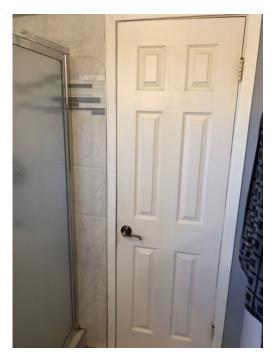
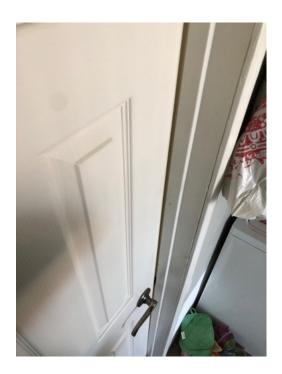
9.6) Bathroom Door Conditions

The door by shower stick at the doorframe and failed to close completely and latch. Repairs and / or adjustments are recommended.

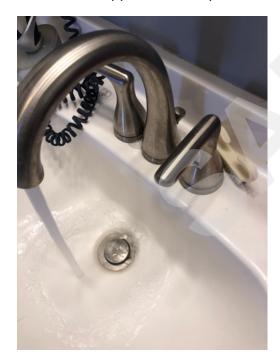
9.11) Sink Conditions

The sink drain stopper did not operate

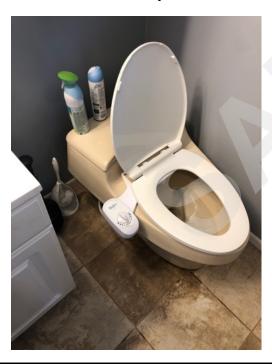
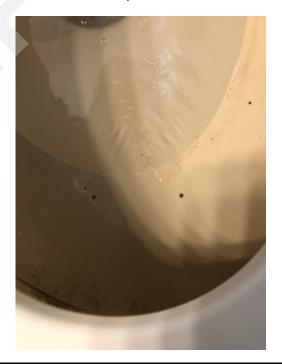
9.13) Toilet Conditions

The water runs continually in the tank. Recommend adjustment and / or repair.

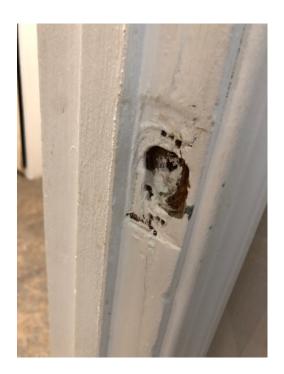
10.6) Bathroom Door Conditions

The interior doors appeared to be in serviceable condition at the time of the inspection. in additional this door is missing strike plate,

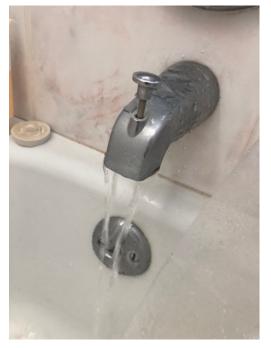
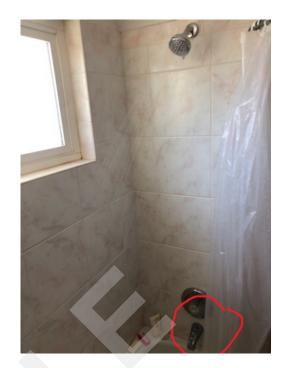
10.12) Shower - Tub Conditions

When the water was diverted from the tub spout to the shower head, some water was still running from the spout. Adjustment or repair may be needed to the diverter faucet or tub spout.

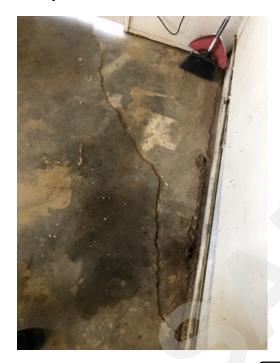
11.3) Floor Conditions

Cracks and settlement were observed to the concrete flooring. Recommend further evaluation by a masonry contractor.

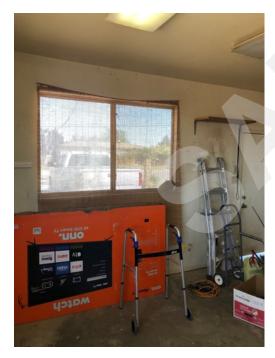
11.6) Vehicle Door Conditions

The garage door has been removed,

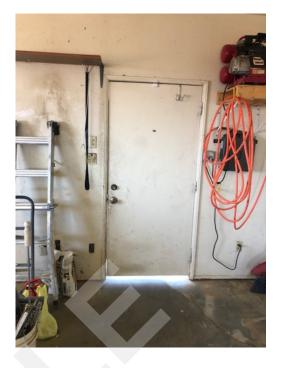
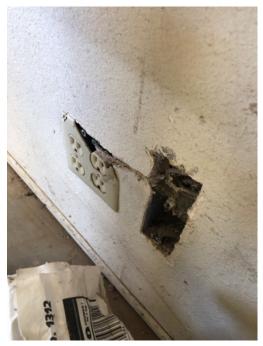
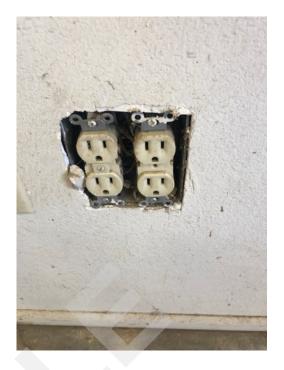
11.7) Electrical Conditions

Junction or switch box covers were missing at . Recommend installation of covers for increased safety.

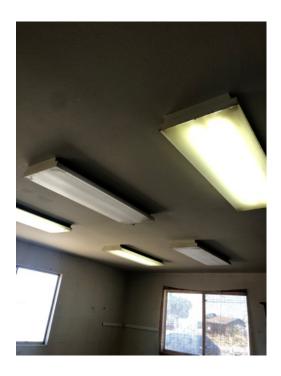
11.8) Lighting Conditions

Some Light(s) were out or inoperative Dismantling and testing of all light fixtures is not performed as part of this inspection. Recommend all lights be operable prior to close.
