Inspection Report

Logic Inspection Inc.

Inspector: Sasoon Yarijanian +1(818)858-5950 AHIT CA Certificate no. 781CA101

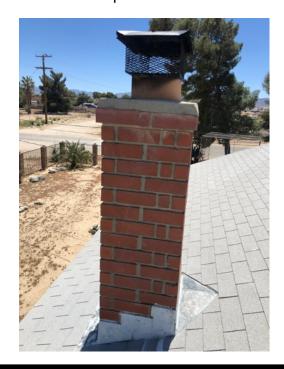
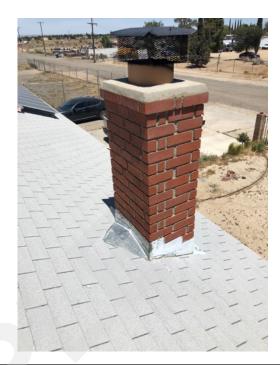
2.7) Chimney Conditions

The visible and accessible portions of the chimney(s) appeared to be in serviceable condition at the time of the inspection.

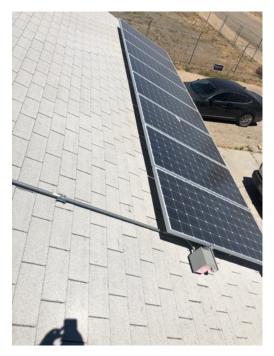
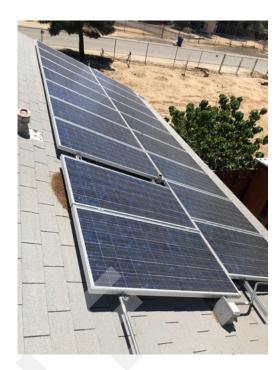
3.1) Roof Covering Condition

The roof covering shows normal wear for its age and appeared to be in serviceable condition at the time of the inspection.

rof is particularly covered with solar panels, unable to inspect that areas.

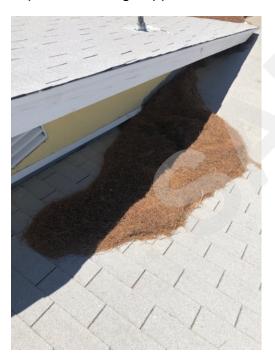
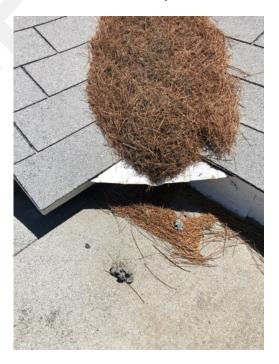
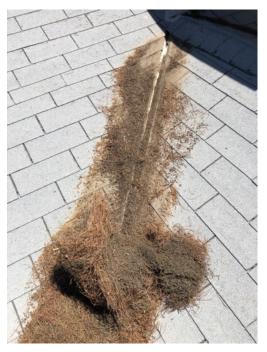
3.2) Flashing Conditions

The exposed flashings appeared to be in serviceable condition at the time of inspection.

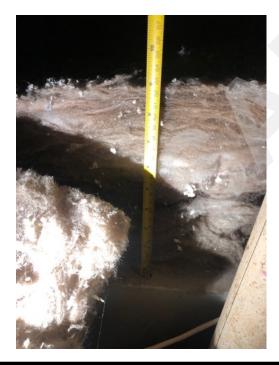
3.8) Attic Insulation Conditions

The attic has blown-in insulation. The approximate depth of the insulation is 10+ inches, which appears adequate.

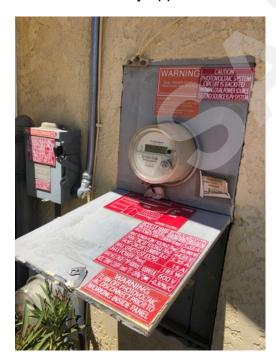
The main service entry appeared to be in serviceable condition at the time of inspection.

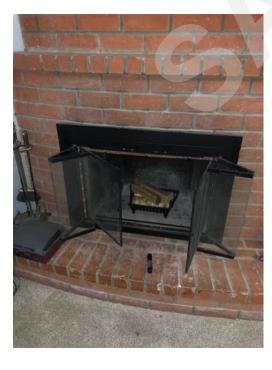
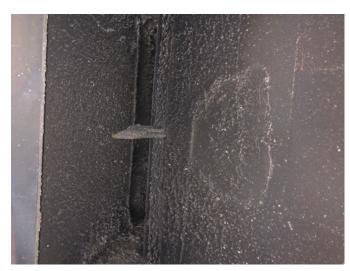
7.11) Fireplace Conditions

The general condition of the visible and accessible areas of the fireplace appeared to be in serviceable condition at the time of the inspection.

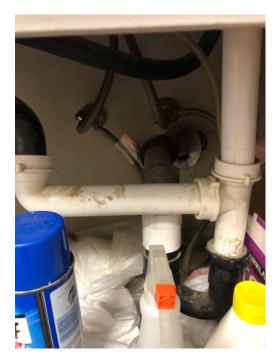
The kitchen sink appeared to be in serviceable condition at the time of the inspection. The faucet appeared to be in serviceable condition at the time of the inspection. The visible areas of the plumbing under the kitchen sink appeared to be in serviceable condition at the time of the inspection.

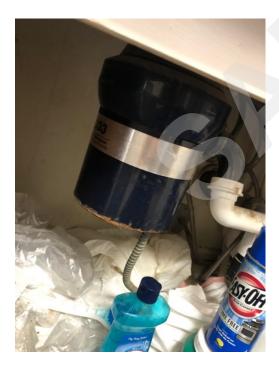
8.12) Garbage Disposal Condition

The sink disposal was operable at the time of the inspection. Client should consult a licensed plumber, manufacturer, or disposal supply company for information on proper usage and safety related concerns.

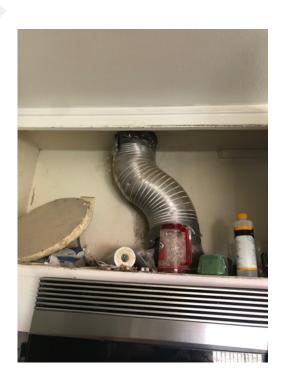
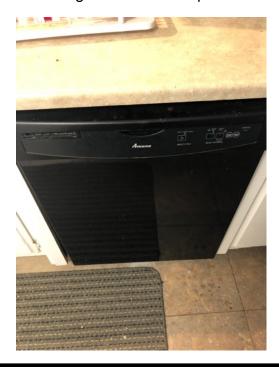
8.15) Dishwasher Conditions

The dishwasher appeared to be in serviceable condition at the time of the inspection. This does not however guarantee future performance or conditions.

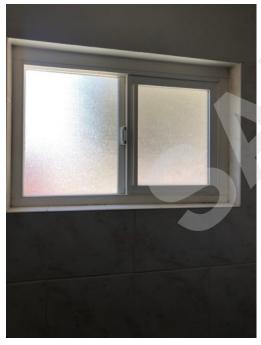
10.5) Bathroom Window Conditions

The sample of windows tested were operational at the time of the inspection.

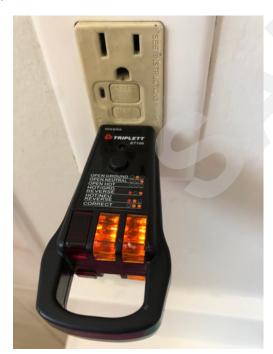
10.7) Electrical Conditions

Appears Serviceable.

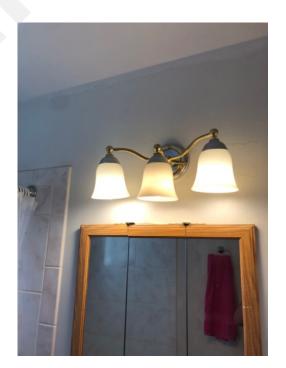
10.8) Lighting Conditions

Appears Serviceable.

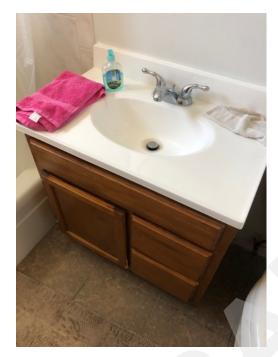
10.10) Counter - Cabinet Conditions

Appears Serviceable.

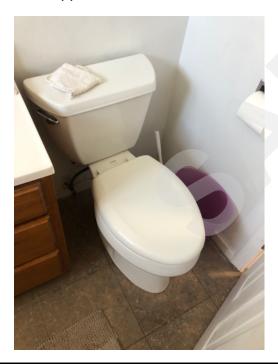
10.13) Toilet Conditions

The toilet appeared to be in serviceable condition at the time of inspection

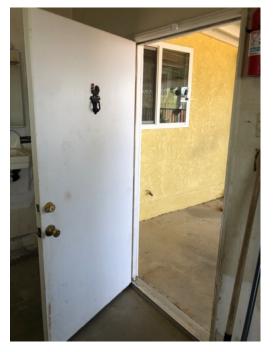
11.5) Door Conditions

The interior doors appeared to be in serviceable condition at the time of the inspection.

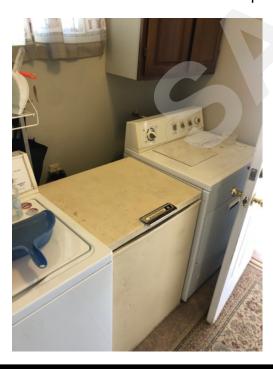
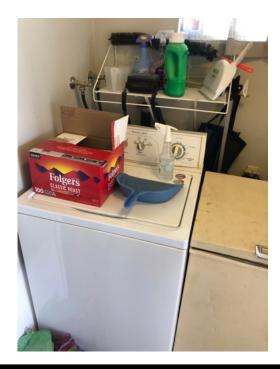
11.9) Laundry Room Conditions

The visible and accessible portions of the laundry plumbing components appeared to be in serviceable condition at the time of inspection.
